**Re: *Baldwin Hill Estates Expansion  
Subdivision Preliminary Plat Application  
CHA Project # 103797***

**Wetland and Waterbodies Delineation Report**

**BALDWIN HILL SECTION 4 &  
BALDWIN HILL APARTMENTS**

**Town of Lysander & Village of Baldwinsville**

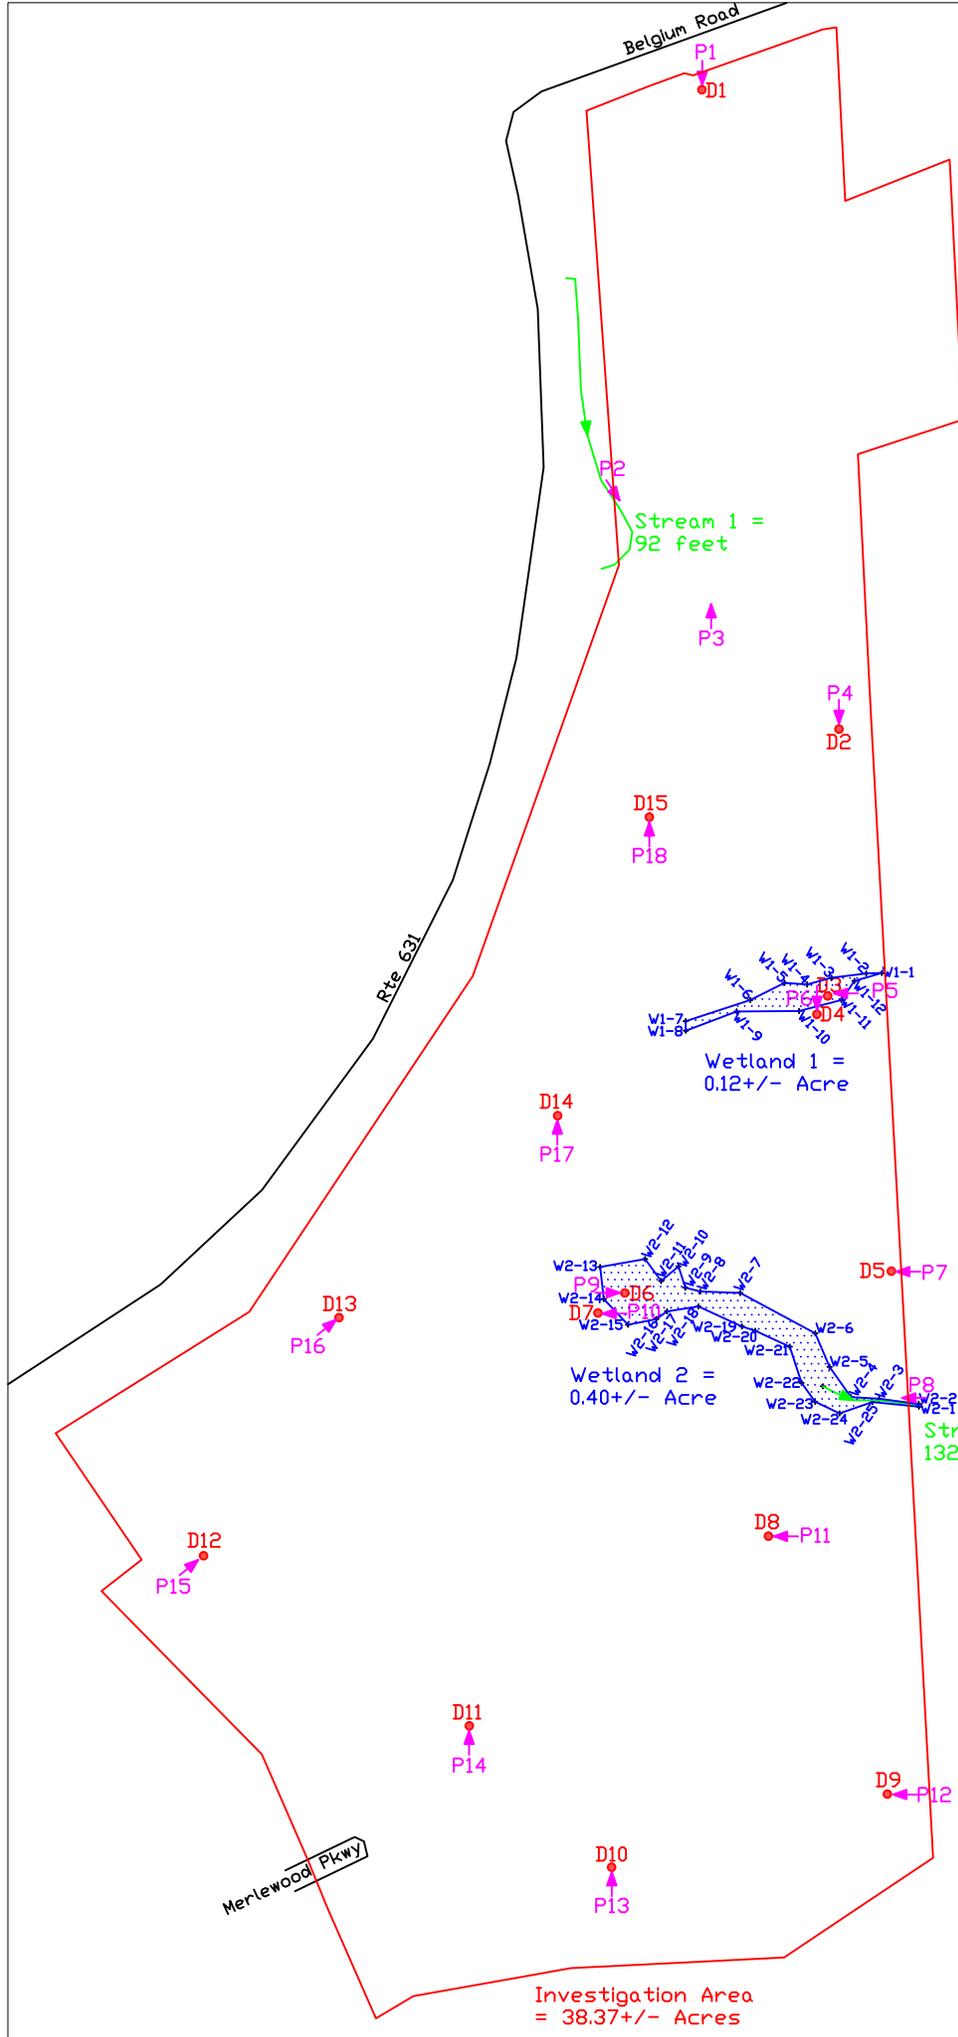
**Baldwin Hill Apartments  
LEGEND**

Investigation Area = 38.37 +/- Acres

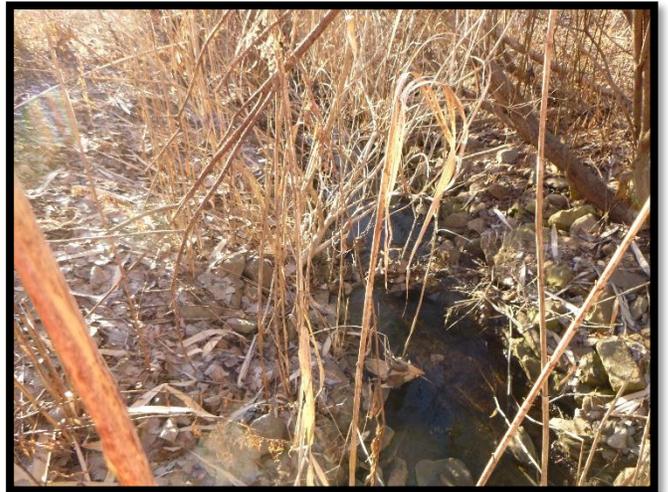
**Photo 2:** Facing southeast. Depicts Stream 1 along the western limits of the investigation area. 2/6/24

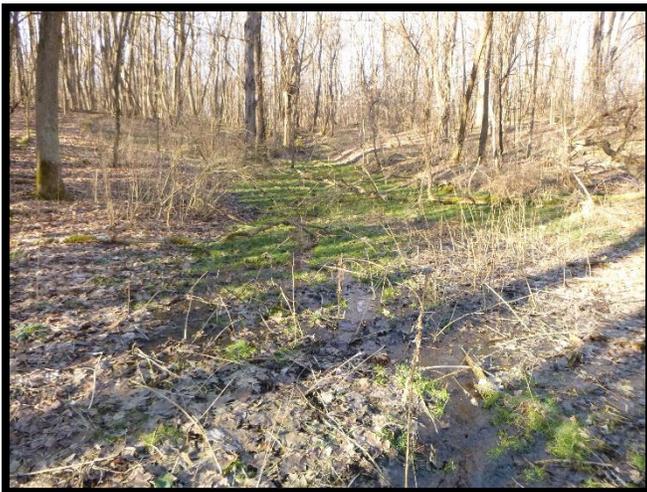
**Photo 5:** Facing west. Depicts the emergent marsh community of wetland W1 at data point D3. 2/6/24

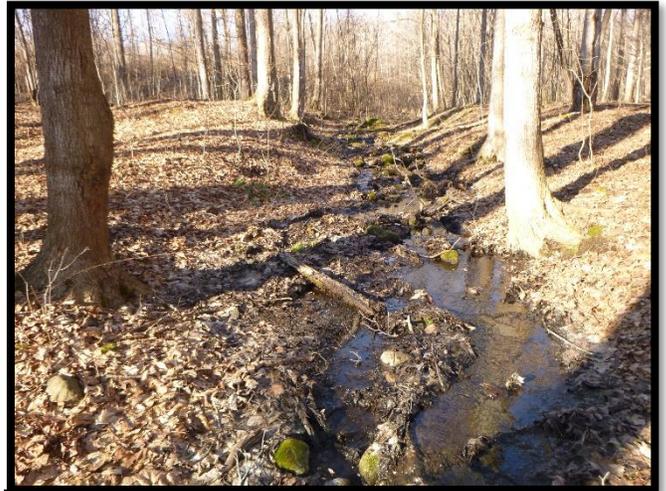
**Photo 8:** Facing west. Depicts Stream 2 flowing east along the east property line. 2/6/24

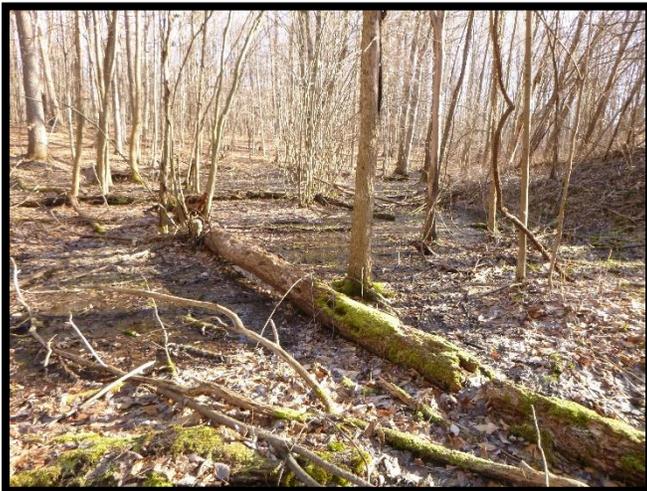
**Photo 9:** Facing east. Depicts the hardwood swamp community of wetland W2 at data point D6. 2/6/24

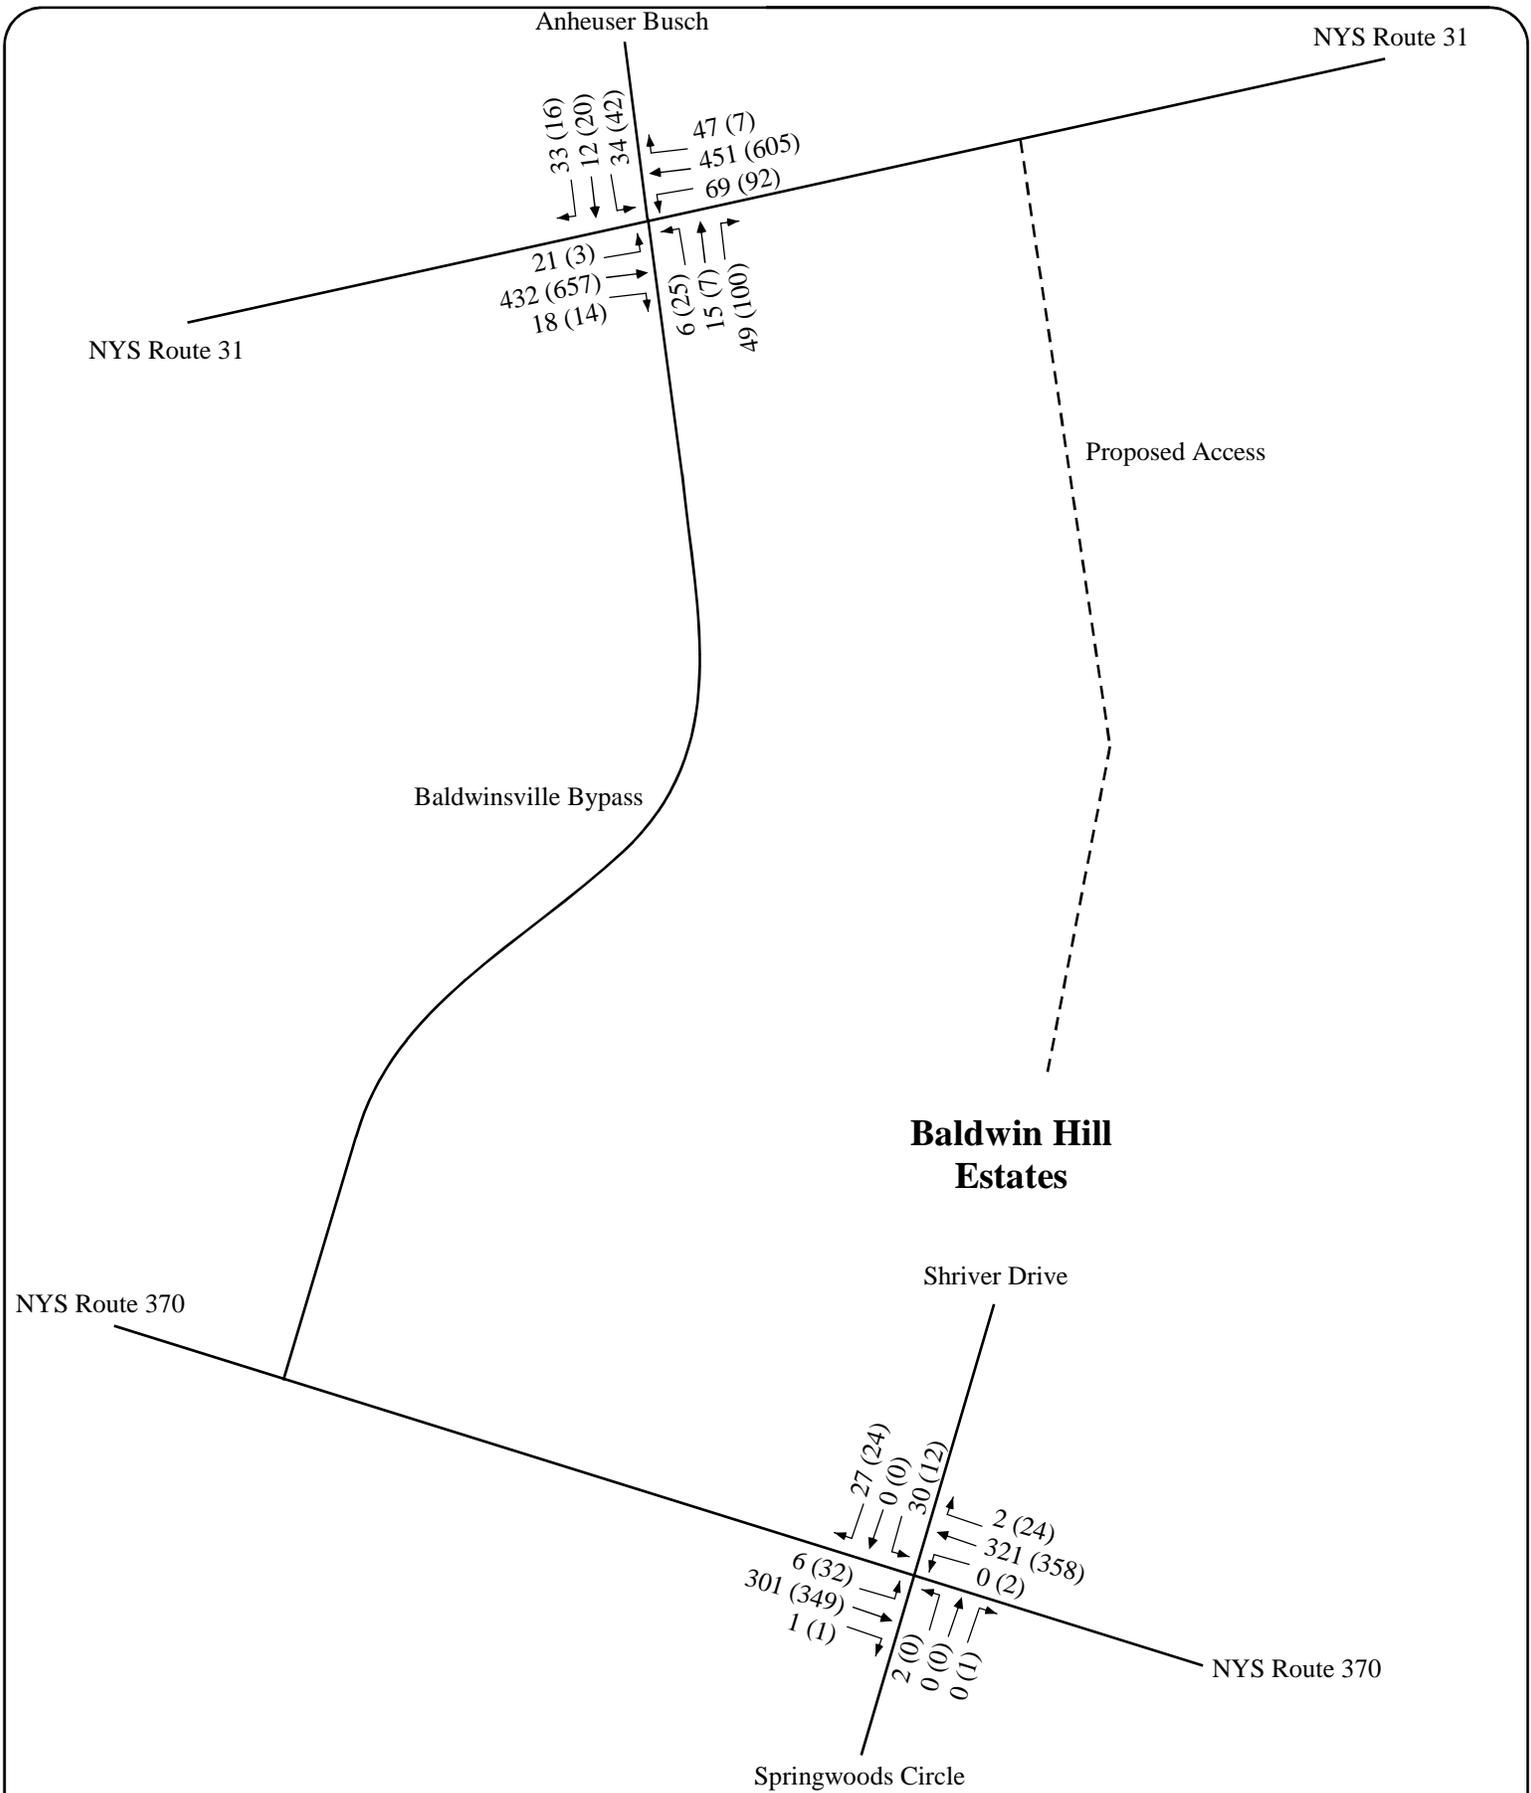
Figure 2

**Proposed Baldwin Hill Estates Expansion - Village of Baldwinsville, NY**  
 2028 Base Traffic Volumes - With 1% Growth per Year (3% Total)  
 Weekday Morning (Evening) Peak Hour

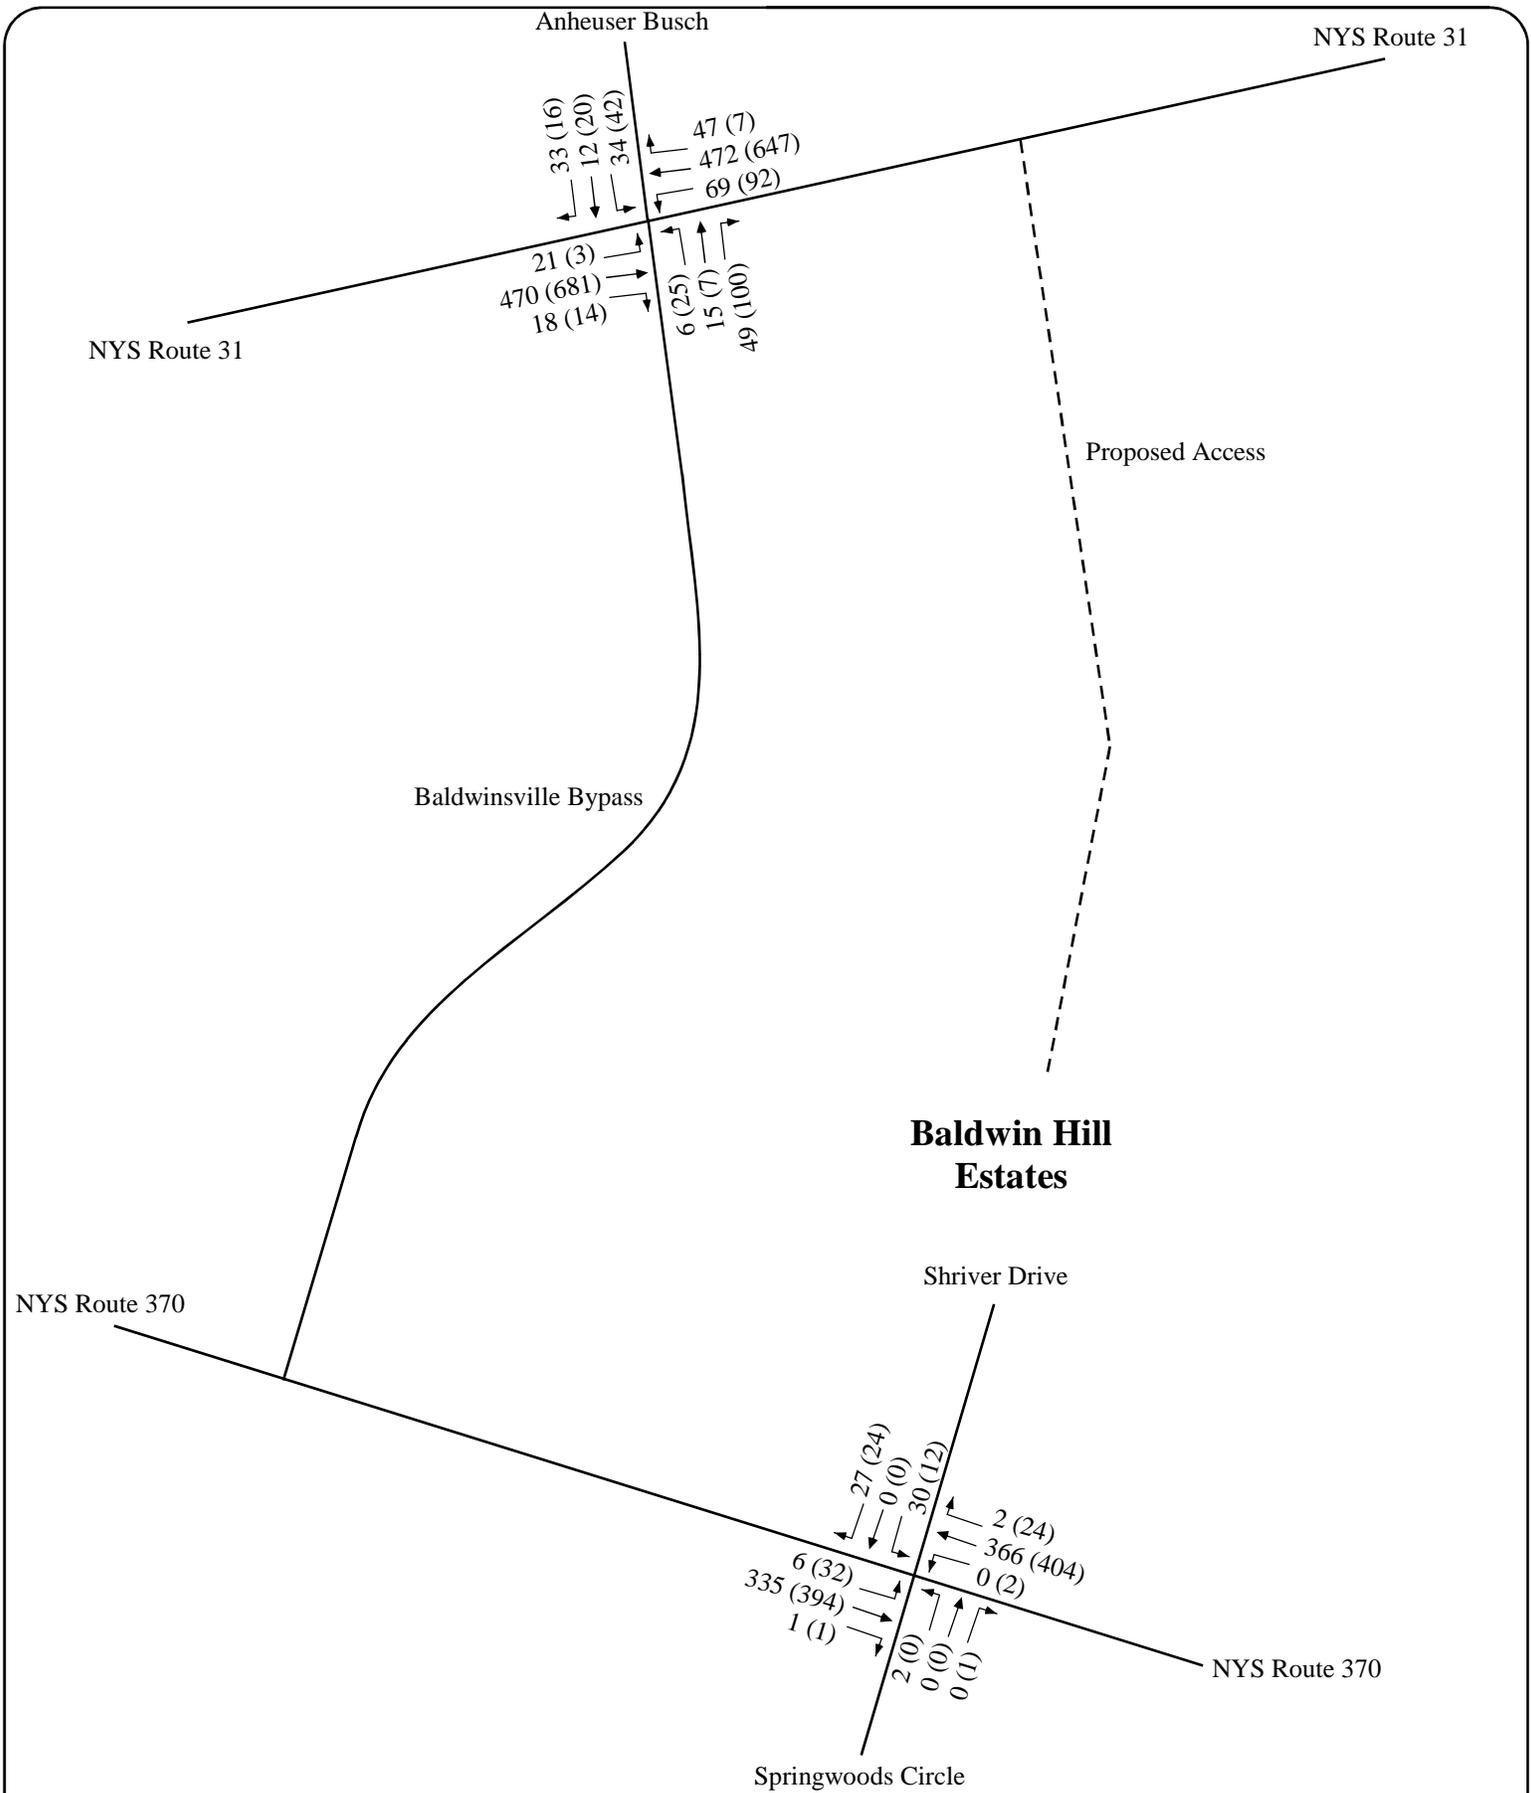
Figure 5

**Proposed Baldwin Hill Estates Expansion - Village of Baldwinsville, NY**  
 2028 Background Traffic Volumes - With Growth & Approved Development  
 Weekday Morning (Evening) Peak Hour

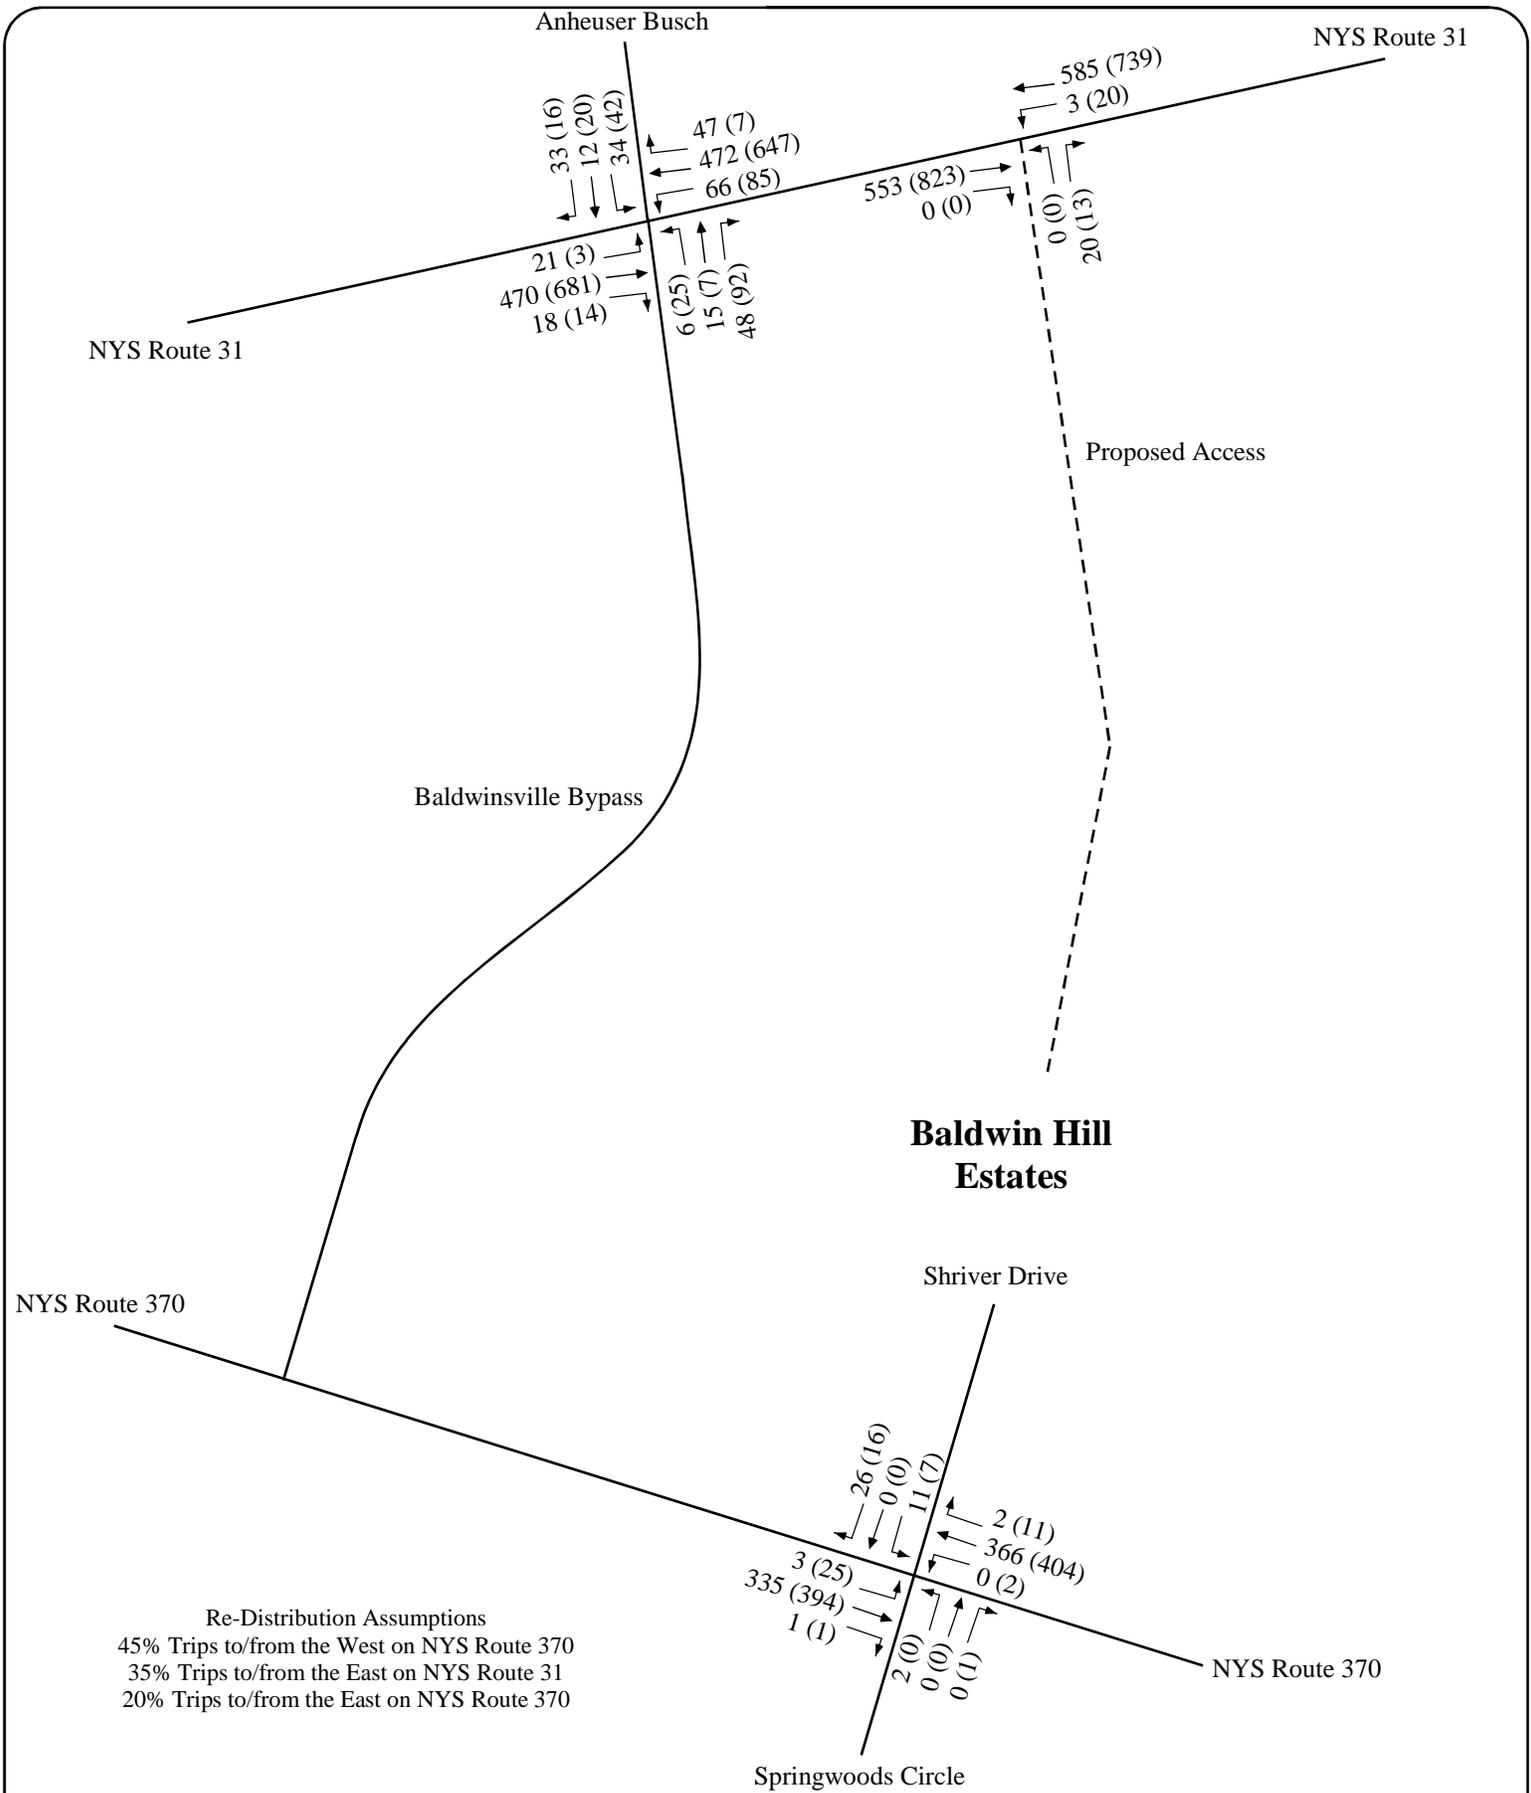
Figure 6

**Proposed Baldwin Hill Estates Expansion - Village of Baldwinsville, NY**  
 2028 Redistributed Traffic Volumes - With Proposed Connection to NYS Route 31  
 Weekday Morning (Evening) Peak Hour

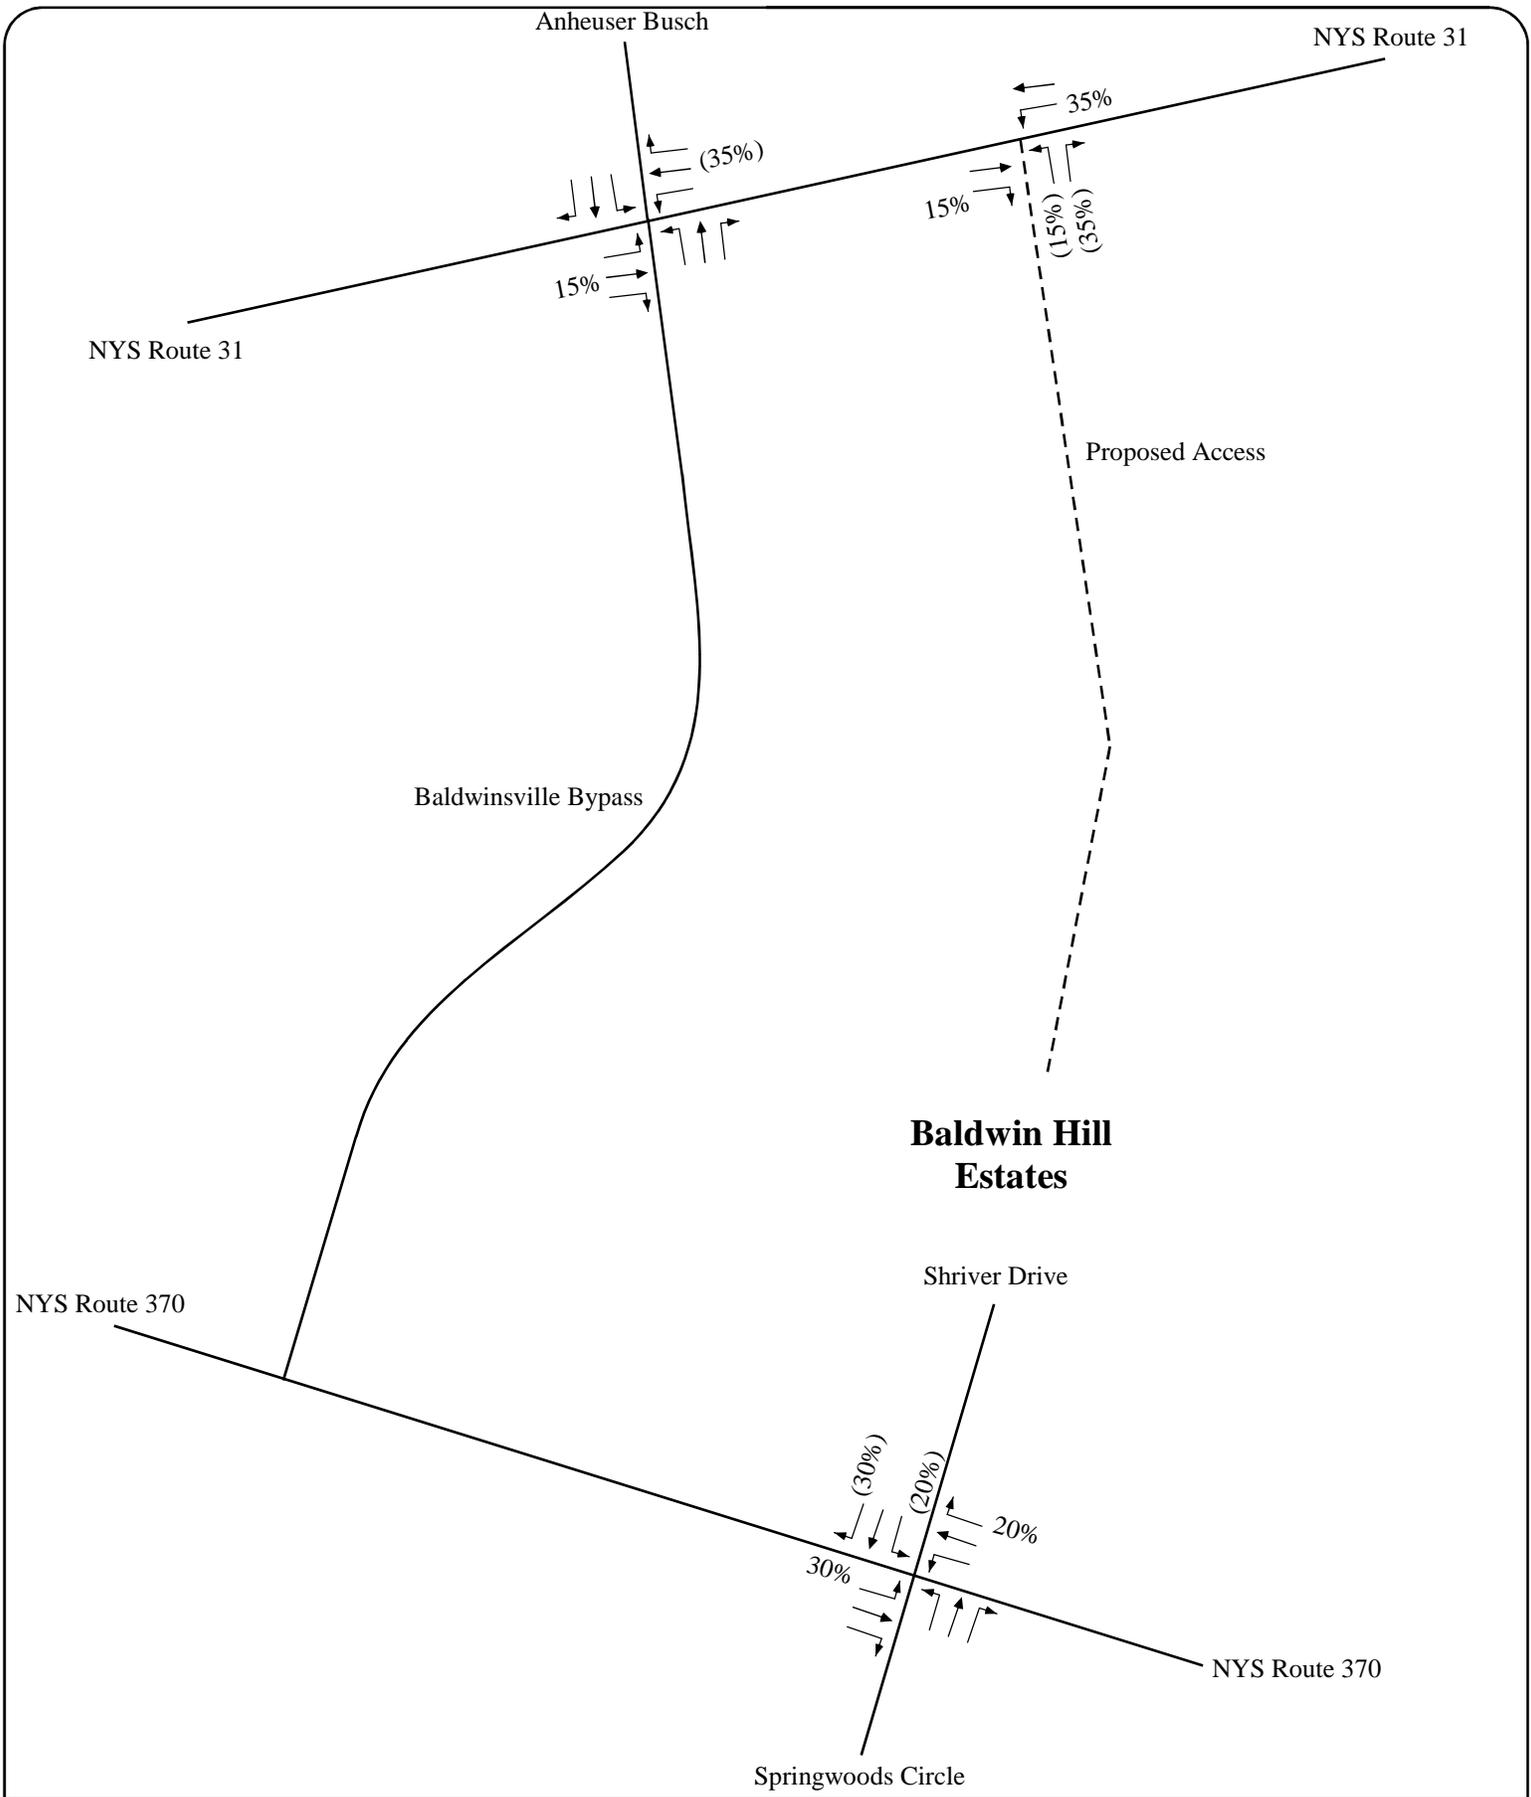
Figure 7

Arrival / Departure Trip Distribution  
 Entering (Exiting) Trip Percentage

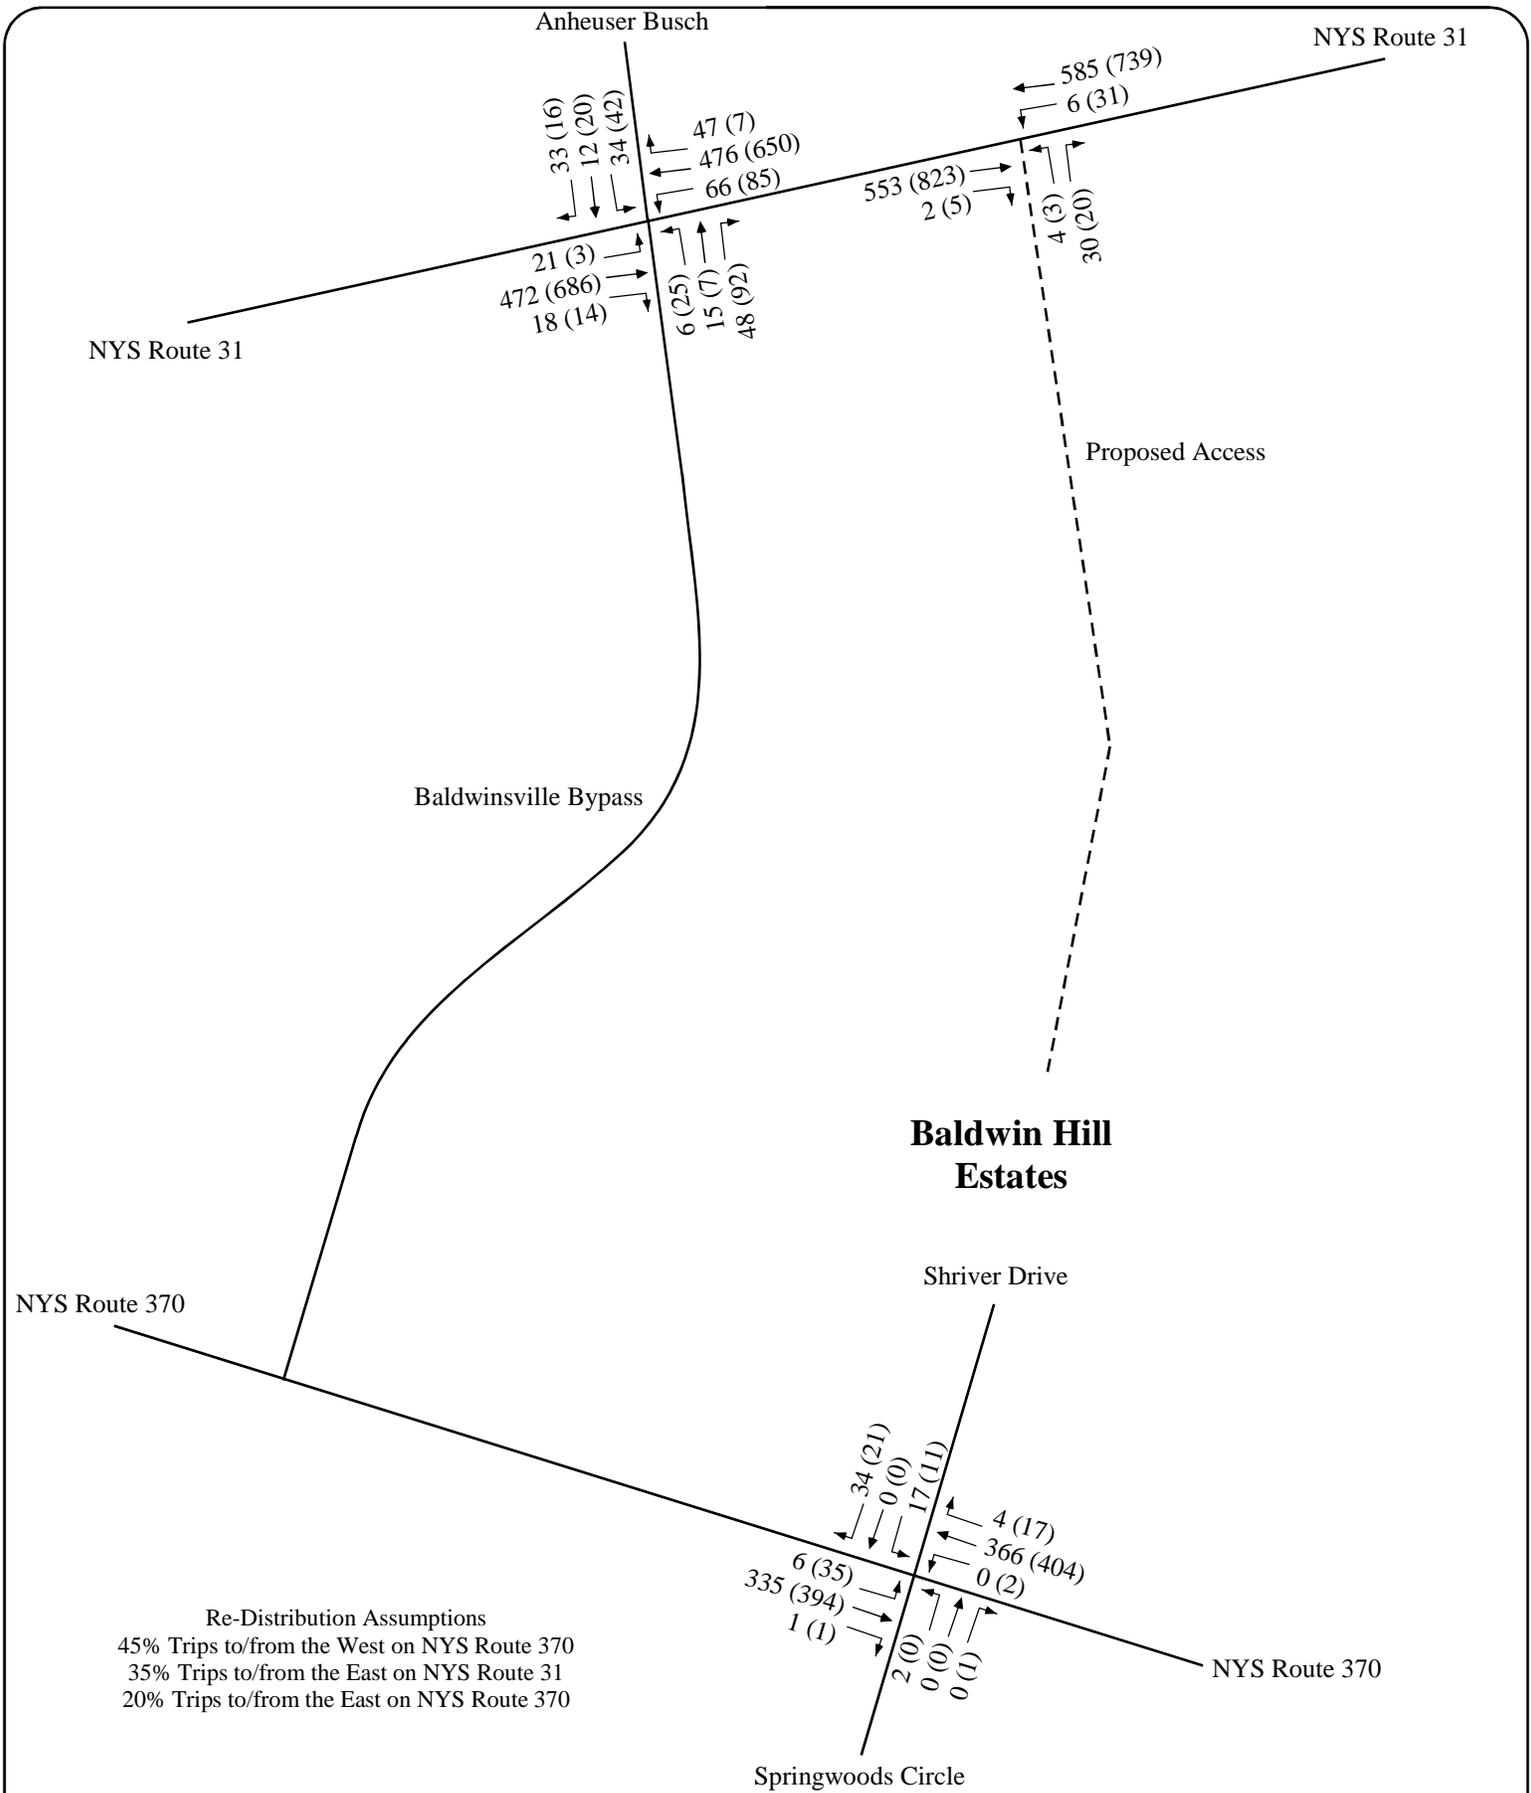
**Re-Distribution Assumptions**  
 45% Trips to/from the West on NYS Route 370  
 35% Trips to/from the East on NYS Route 31  
 20% Trips to/from the East on NYS Route 370
